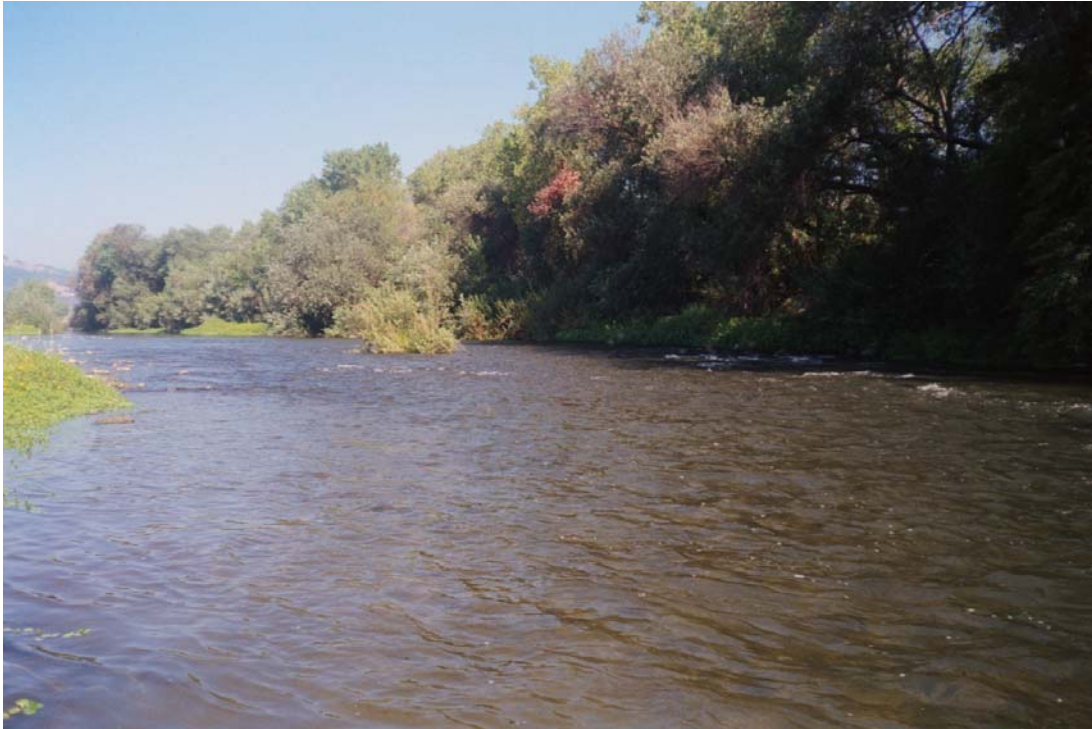
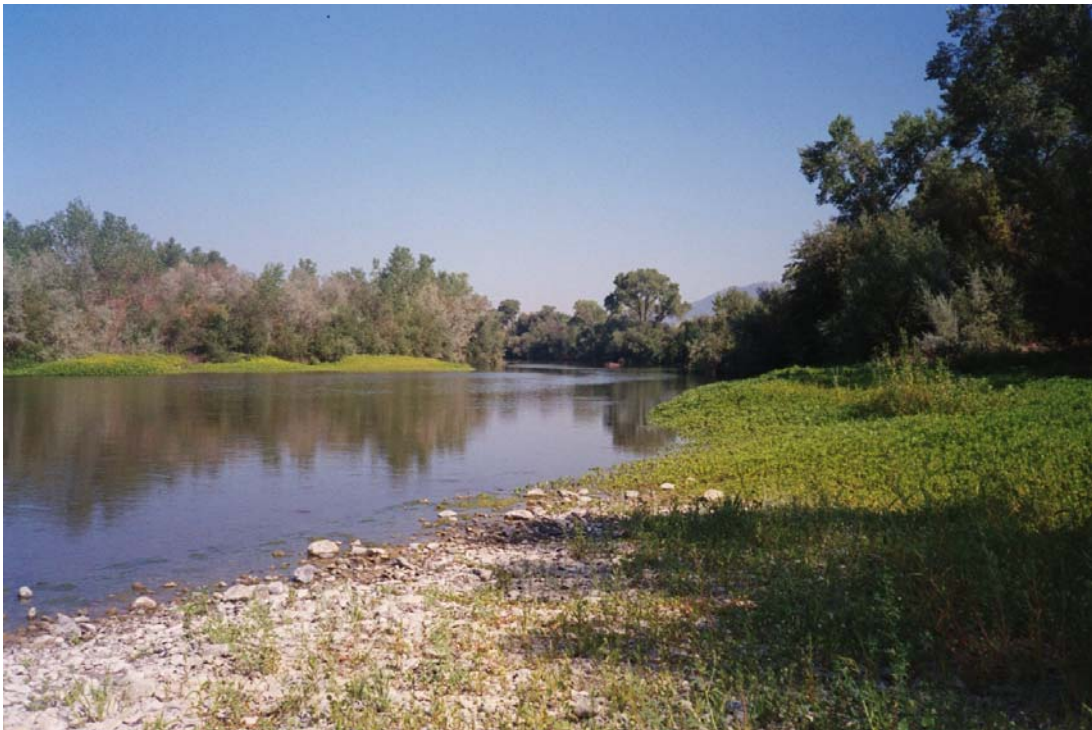
Figure 28: Alexander Valley Reach, Segment A2. This segment was dominated by flatwater habitat with broad gravel bars. No steelhead observed.

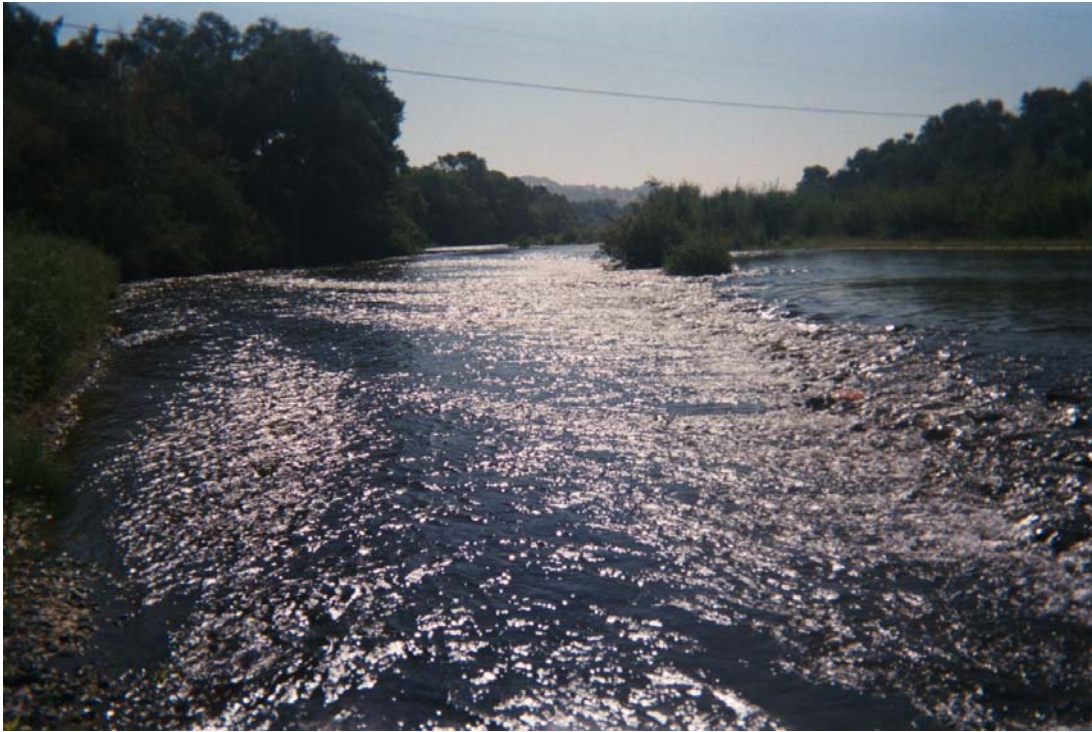
Figure 29: Alexander Valley Reach, Segment A3. This segment contained 1% riffle, 2% deep pool, and 97% flatwater habitats. The top photograph shows a small shallow riffle. Flatwater habitat with adjacent broad gravel bars and sparse riparian cover dominated the segment (bottom). No steelhead were observed.

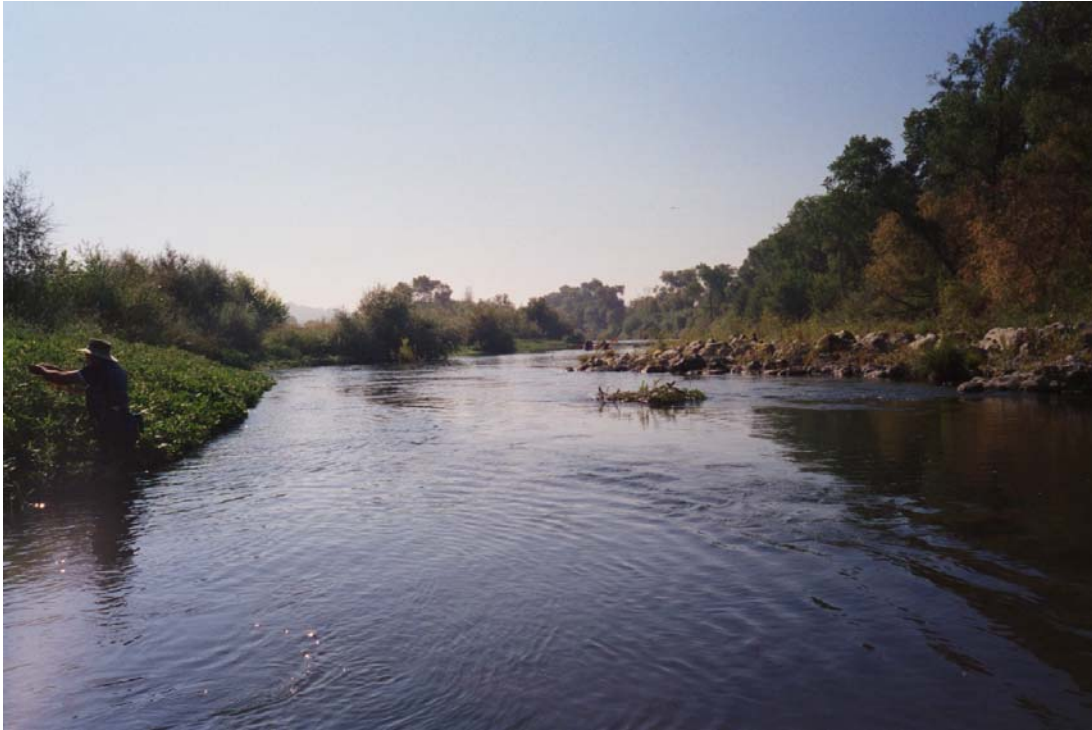
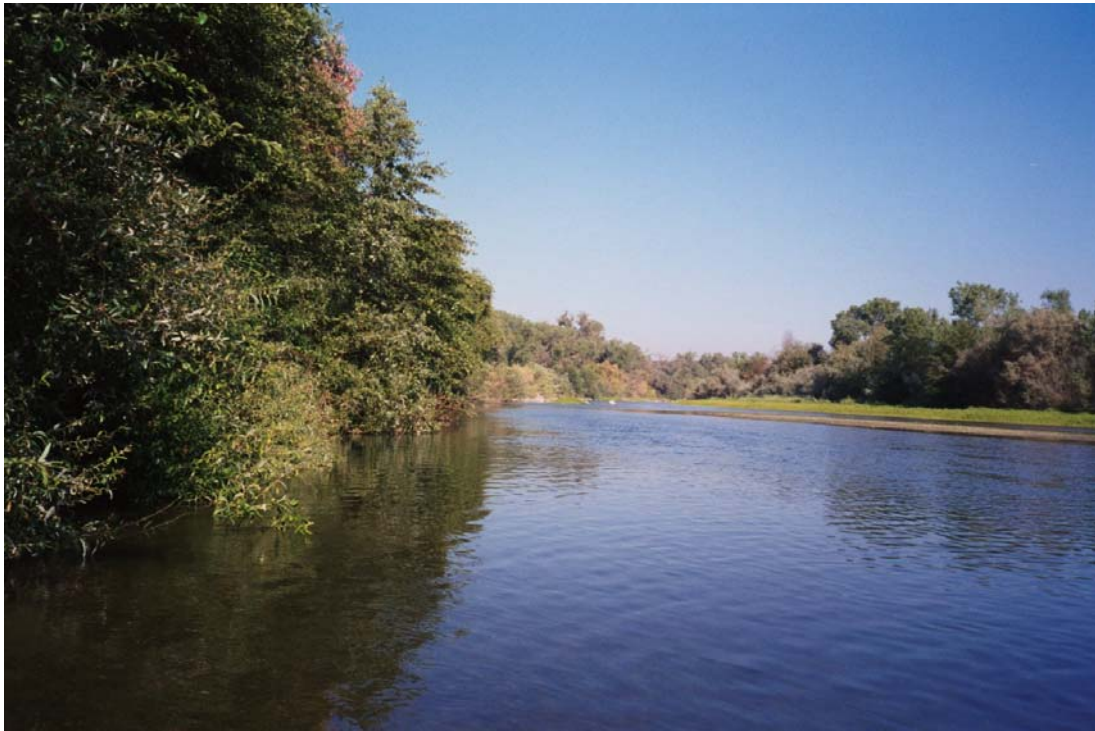
Figure 30: Alexander Valley Reach, Segment A4. This segment consisted of flatwater habitat. No steelhead were observed.

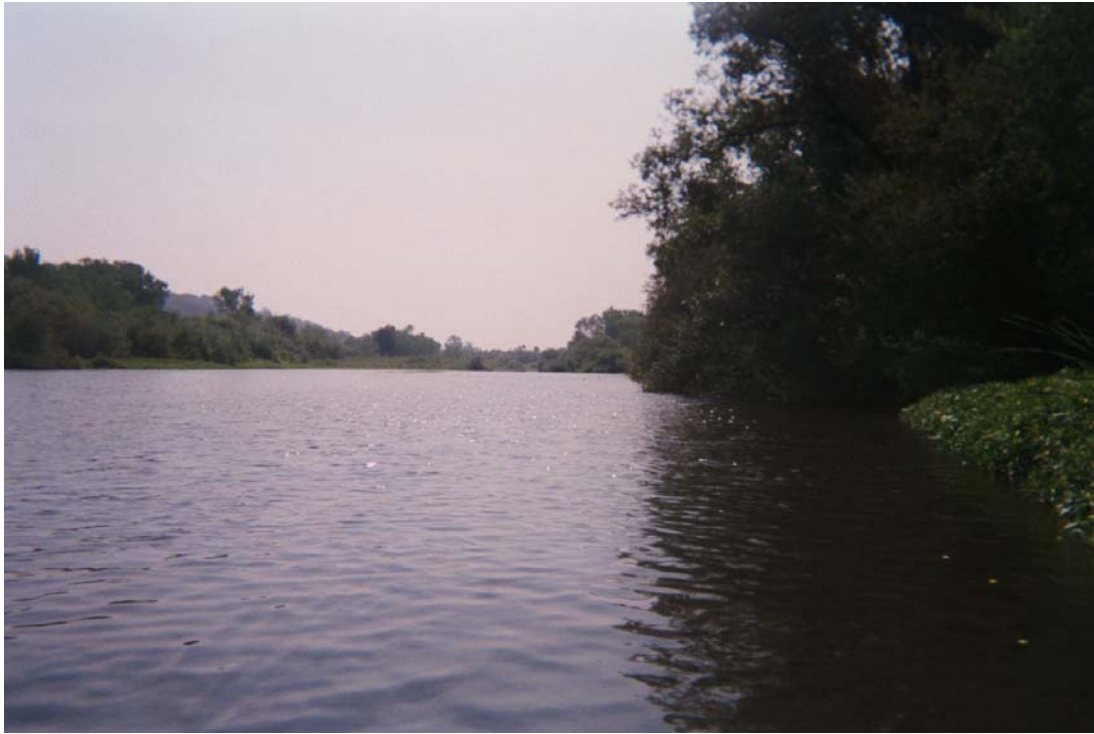
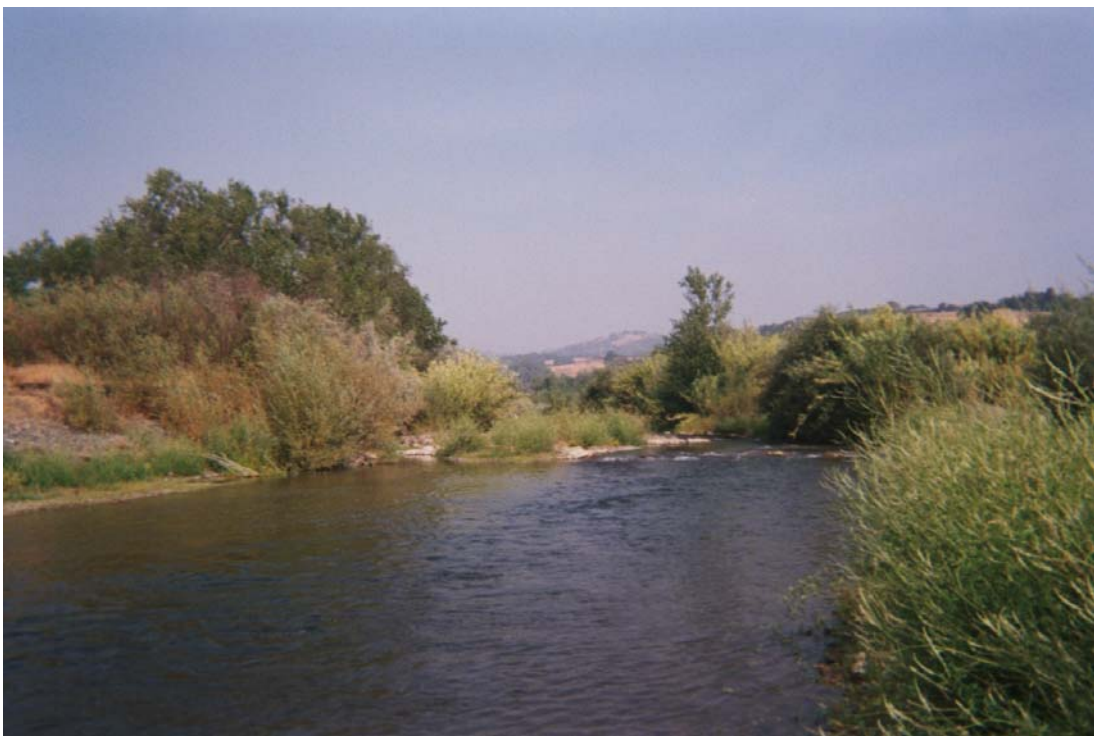
Figure 31: Alexander Valley Reach, Segment A5. This segment contained 99% flatwater, a broad streambed with shallow depths, and sparse riparian cover. No steelhead were observed.
